CONNECTICUT RIVER BASIN  
WESTFIELD, MASSACHUSETTS

STEVENS PAPER COMPANY  
(LOWER DAM)  
MA 00074

PHASE I INSPECTION REPORT  
NATIONAL DAM INSPECTION PROGRAM

MARCH 1979  
84 09 05 114

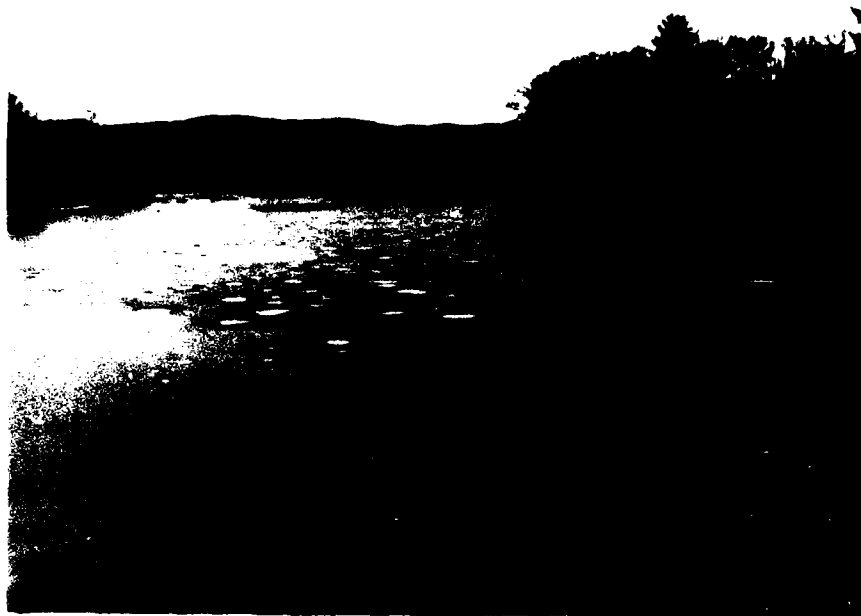
PHOTO NO. 13 - Upstream channel.
